Nnaji CC, Udokpoh UU, Ifeakor AR. Assessing the efficiencies of domestic water pumps and distribution systems for household water supply in Enugu State, Nigeria. *Indian Journal of Engineering*, 2024, 21, e5ije1680

Assessing the efficiencies of domestic water pumps and distribution systems for household water supply in Enugu State, Nigeria

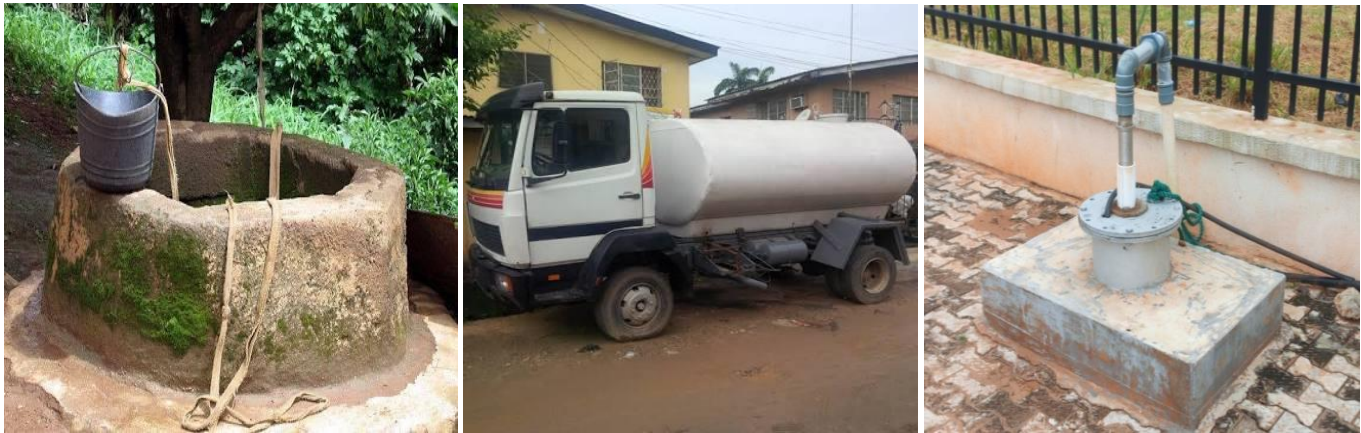
Figure 2 Prevalent means of water supply in the study area

High-rise buildings in the study area suffer greatly from inadequate water supply since most of them are not designed and built with a functional water supply system. Also, due to the relatively low supply of water provided by Enugu State Water Cooperation, these buildings have resorted to other sources of water, such as ground wells, water tanker trucks, and boreholes, as shown in (Figure 2).

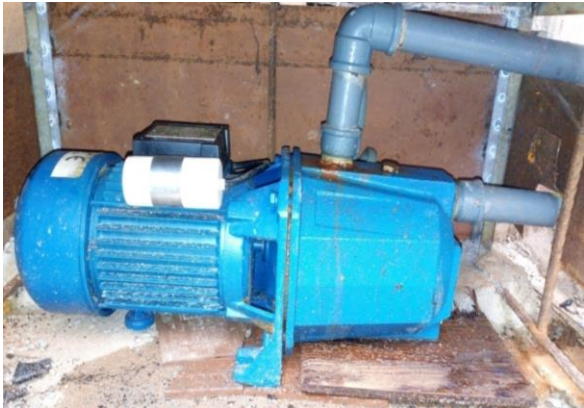
Figure 5 Typical ATLAS 125 pump

This surface centrifugal water pump is perfect for water delivery from wells and reservoirs in domestic, public, industrial, garden, and irrigation applications. For optimal performance, it should be used with either a foot valve or a non-return valve, and it is intended for transfer purposes.

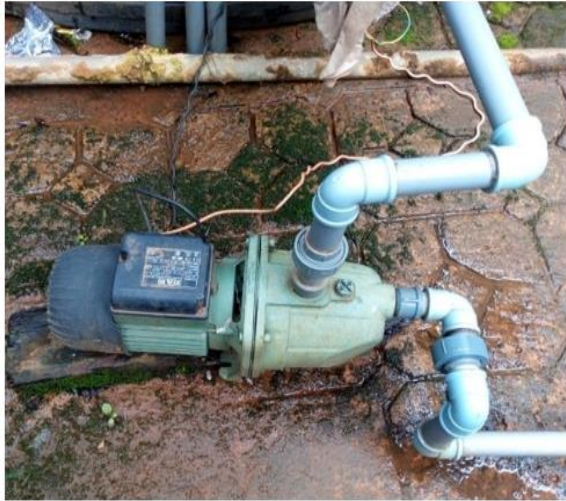
Figure 6 Typical DAB JET 102 M pump

This is a centrifugal jet pump made of self-priming stainless steel and cast iron. The exceptional deep suction capabilities and distinctive self-priming features of DAB jet pumps have earned them a widespread reputation. These devices are specifically engineered to effectively manage water that is both abrasive and corrosive, particularly for spear tip applications. This system is appropriate for providing water in residential settings, small-scale farming, and gardening.

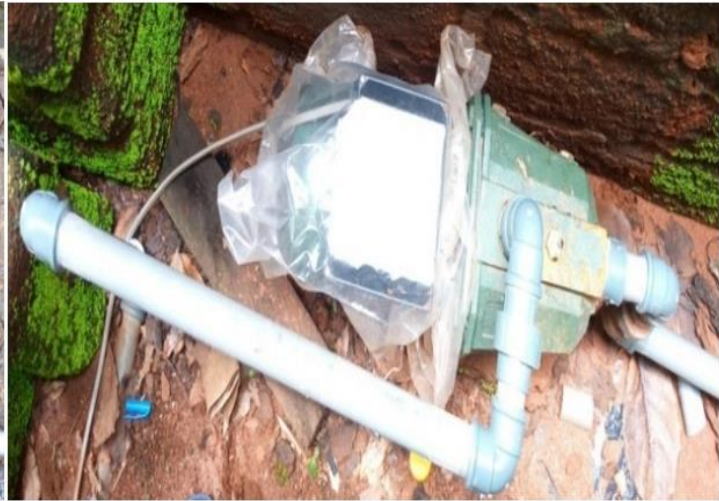
Figure 7 Typical GRANAC JET 100M pump

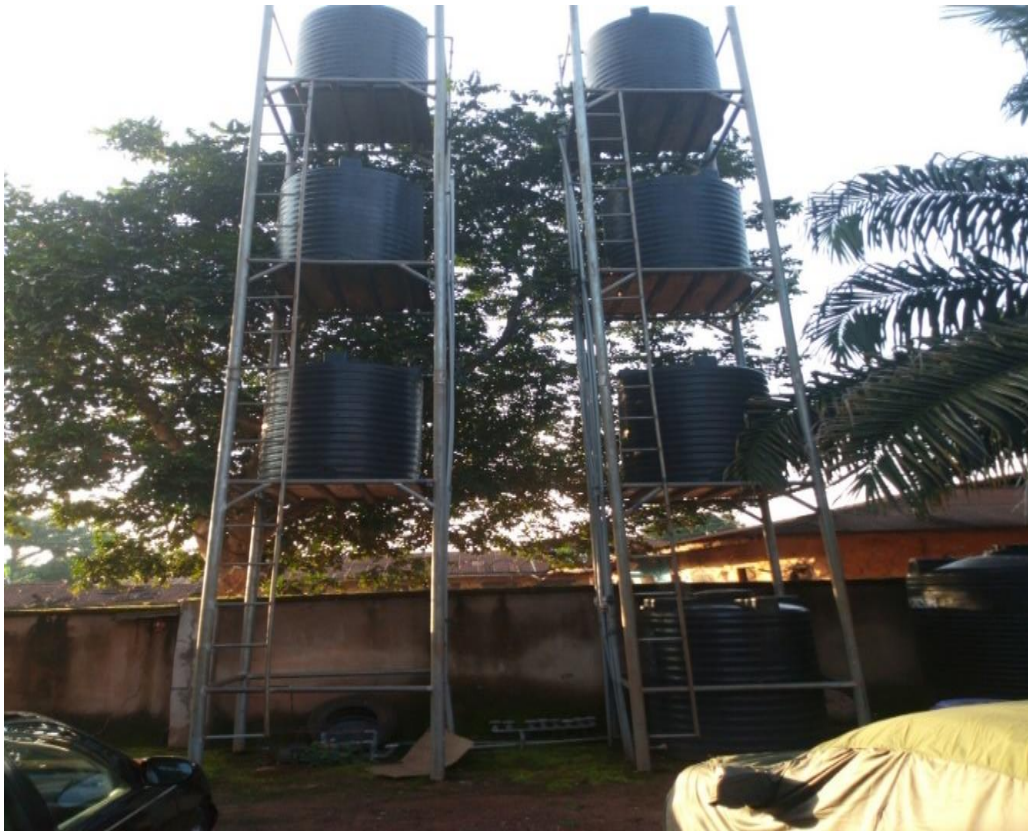
Figure 8 Prevalent storage tanks in the study area

During this survey, various types of storage tanks and piping systems were accessed and considered. This information was used to understand the reasons behind the quantity of water supply. It was also used as a consideration for low pumping efficiency, resulting from different losses experienced by various types of piping systems seen in this study. Below is a pictorial presentation of the prevailing kinds of storage tanks and the various piping systems in the study area. From the survey, it was observed that most house owners use plastic tanks, commonly referred to as GeePee tanks, as seen in Figure 8, and their choices were influenced by cost, availability, durability, and their anti-corrosion potential.

Although most rubber tank owners prefer it to steel and fiberglass tanks because of their price, if the steel and fiberglass tanks are adequately used, their lifespan is far longer than that of rubber tanks. These storage sizes range from 750 liters to 4000 liters. However, the piping system observed in the study area was not correctly done, as seen in Figure 9a, 9b. Also, it was observed that the pipes were leaking. This could be the reason for the poor pump efficiencies recorded. The prevalent types of pipe material used in the area were polyvinyl chloride (PVC) and asbestos cement pipelines.

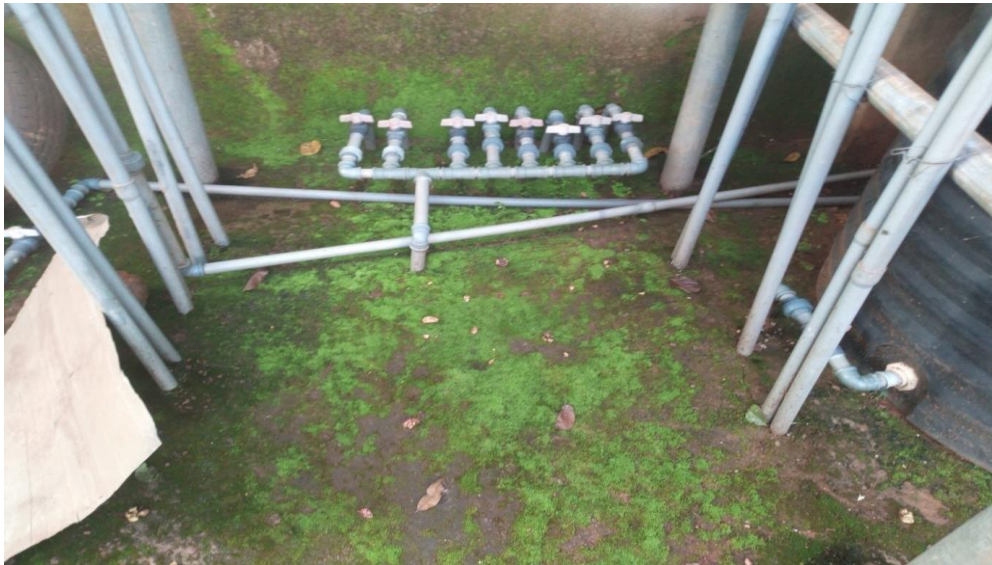
Figure 9a Piping layout at reservoir area

Pump pipework is designed to facilitate the transfer of liquids to and from a pump while ensuring the pump remains reliable and efficient. Conversely, insufficient system piping is the root or a contributing factor in many pump performance and reliability issues (Klingel, 2012). Regarding a pump's efficiency, the suction pipe is far more critical than the discharge pipe. To prevent cavitation and the damage it causes, suction pipework distributes the liquid flow to the pump suction in an even pattern while maintaining a pressure high enough to harm the pump. This situation poses many risks to the pump as it requires the suction pipe to convey the liquid to it.
